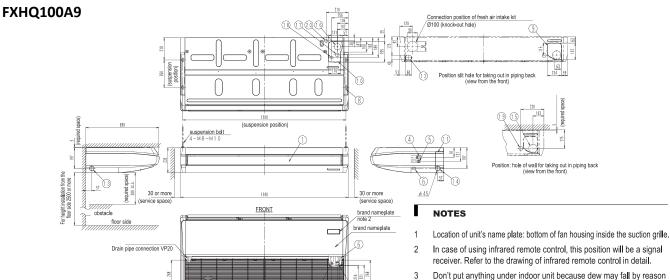
Nr	Name	Description
1	Air discharge grille	
2	Air suction grille	
3	Air filter	
4	Gas pipe connection	Ø15.9 flare
5	Liquid pipe connection	Ø9.5 flare
6	Drain pipe connection	VP20
7	Earth terminal (inside electric components box)	M4
8	Hanger bracket	
9	Backward piping and wiring connection opening lid	
10	Upward piping and wiring connection opening lid

z. The drain outlet is stopped up.	
The air filter is dirty.	
Right side pipe connection	slit hole
Left back drain pipe connection	slit hole
Left side drain pipe connection	slit hole
Right side drain pipe connection	slit hole
Hole of wall for taking out in piping back	Ø100
Upward drain pipe connection	Ø60
Upward gas pipe connection	Ø36
Upward liquid pipe connection	Ø26
Power source wiring and a unit wiring back connection	Ø29
Power source wiring and a unit wiring upper connection	Ø29
	3. The air filter is dirty. Right side pipe connection Left back drain pipe connection Left side drain pipe connection Right side drain pipe connection Hole of wall for taking out in piping back Upward drain pipe connection Upward gas pipe connection Upward liquid pipe connection Power source wiring and a unit wiring back connection
